UT PLANT

(KUMHO PNB Chemicals UT Plant)

Fuel Residue Pre-Heat Exchanger Maintenance Report in May/2005

1) EA-1821 and EA821 Pre-Heat Exchanger Tube Cleaning Precess

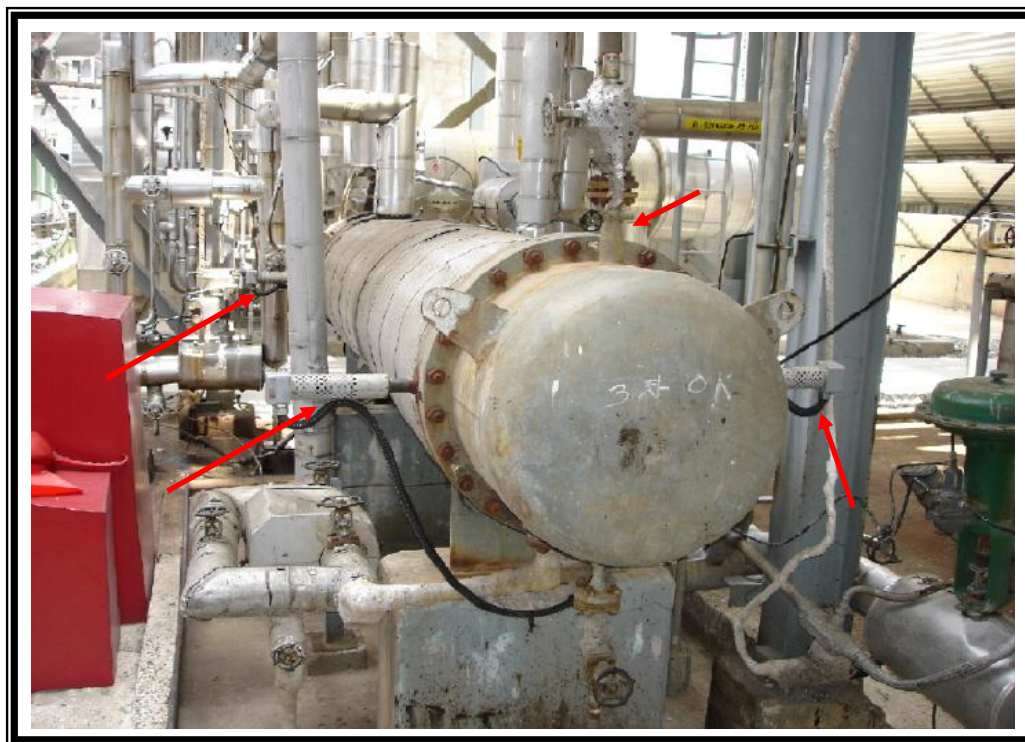
▶ 4 transducers was installed on the both tube sheets

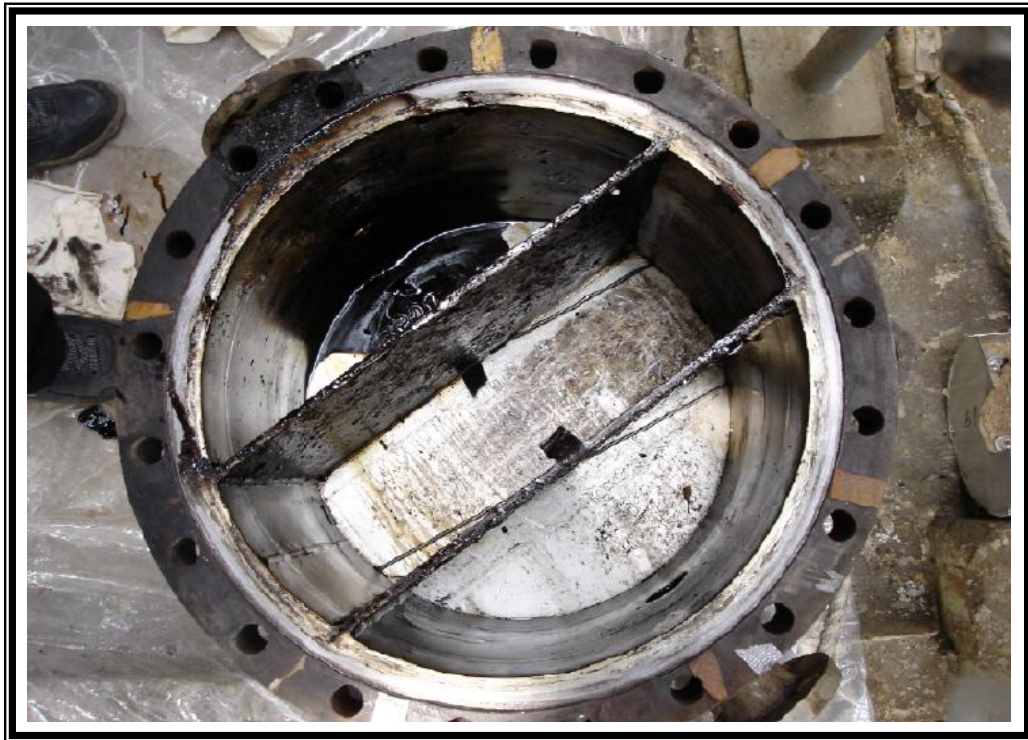
► status after the opening of shell cover – no fouling found and good condition

* Very clean

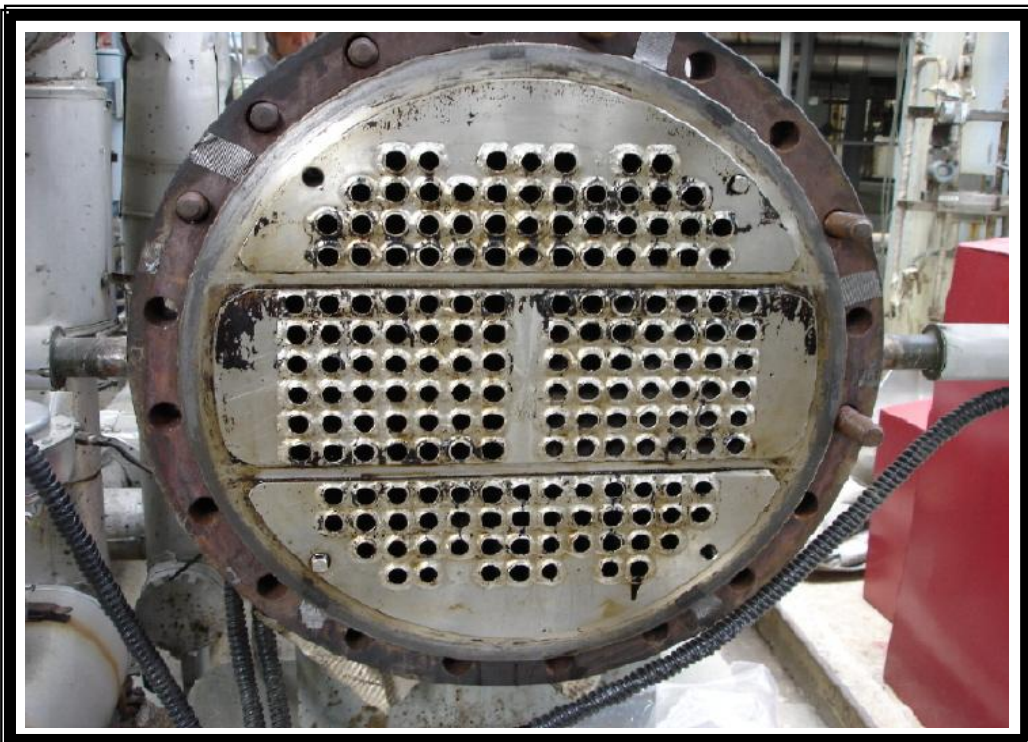
► status of exchanger shell tube after opening

status of tube inside was very clean and no clogged

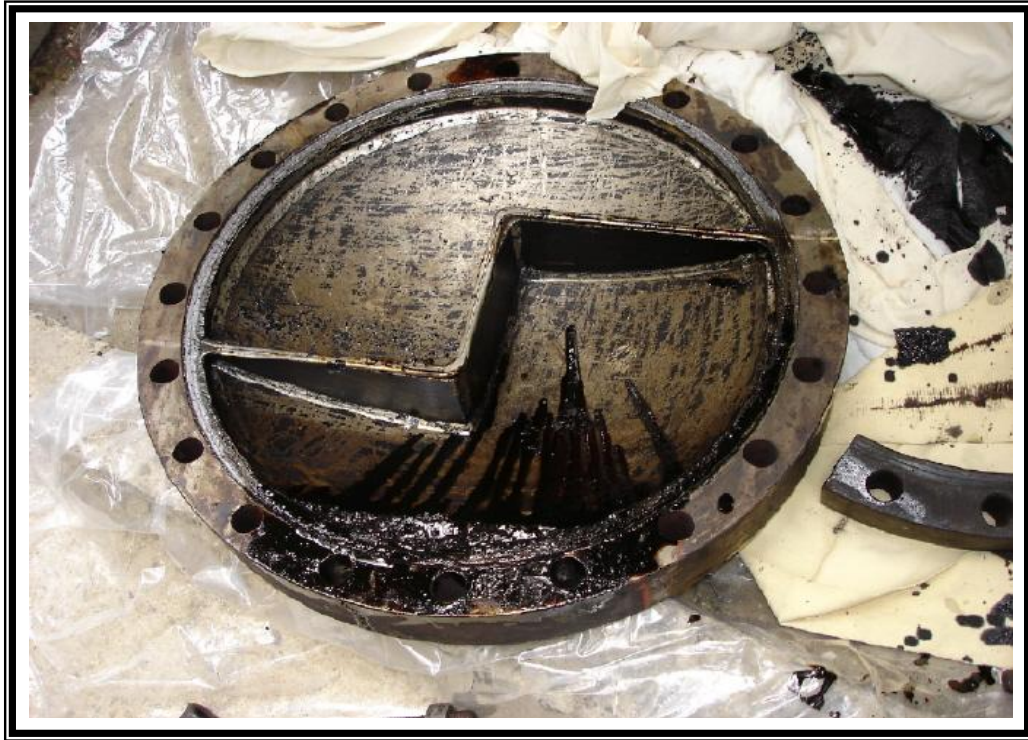
► status of other side shell cover after opening

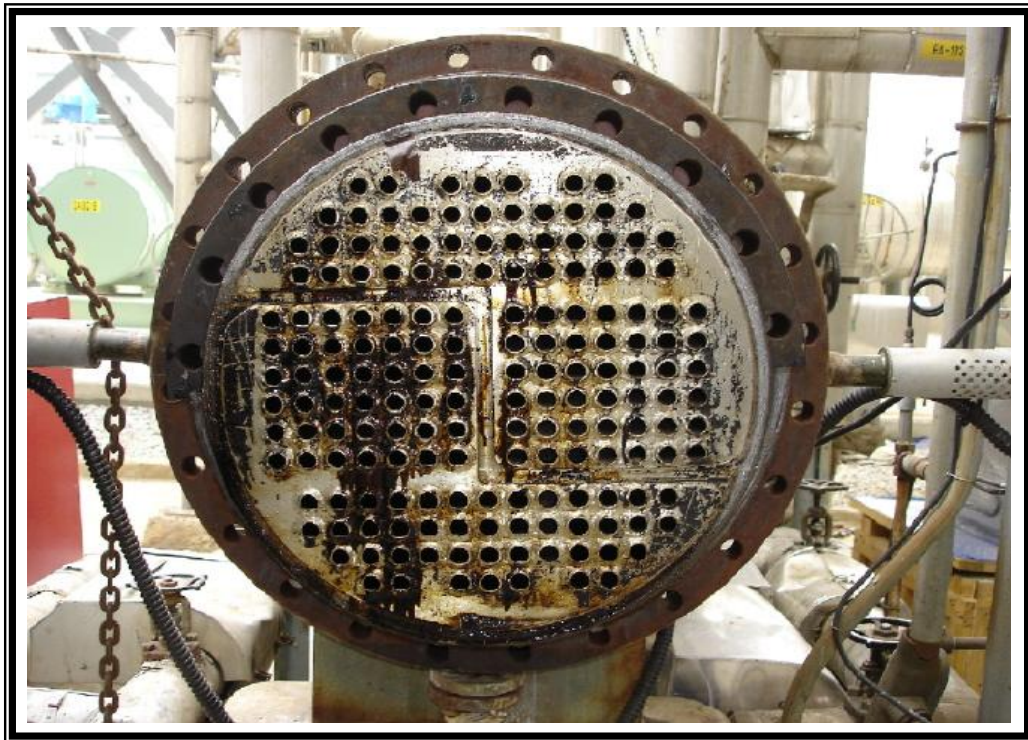
► status of other side tube

* Because we are using the B/C oil + Fuel Residue, We have found the bad and high viscosity tars in the tube. As they clogged about 2/3 of tubes, we could not control flow valves. These have been made some troubles in S/D process. Since the USP was installed, no foulings found. Therefore no cleaning process was required.

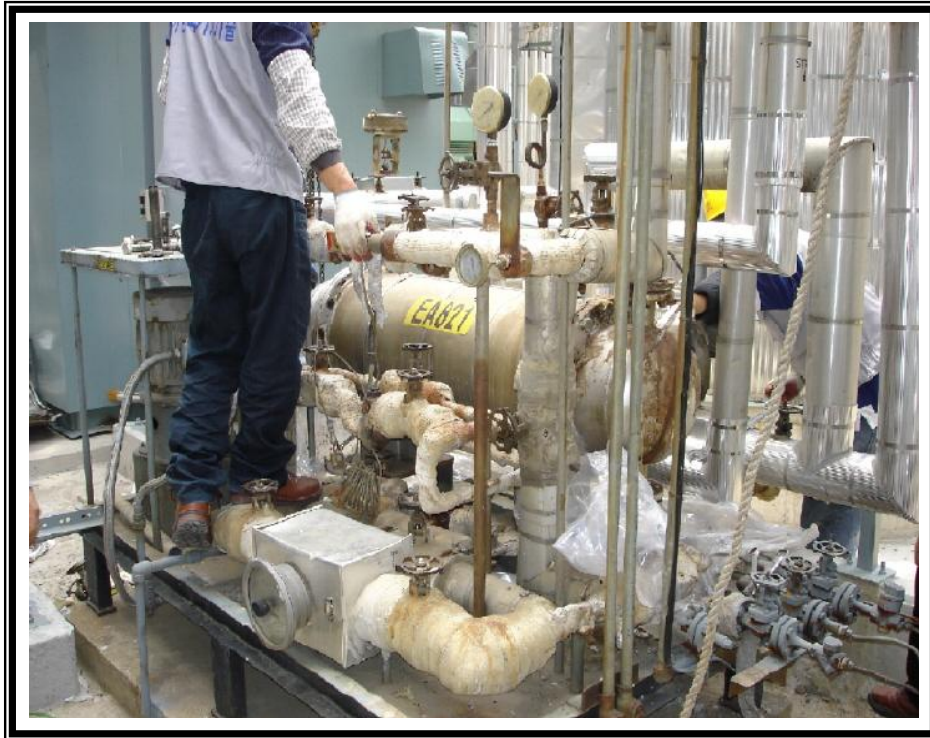
- ◆ EA-1821 : 1 year operation with USP. No cleaning is required.
- ◆ EA-821 : 1 year operation without USP. There are lots of fouling(high viscosity tars) inside of exchanger and needs the cleaning.

► Before cleaning

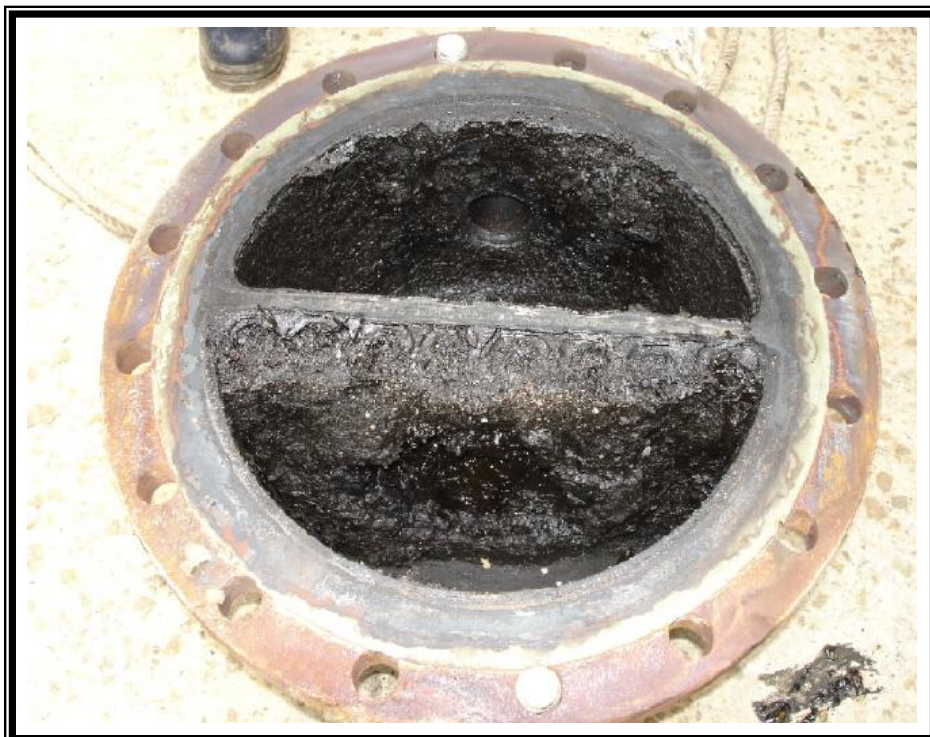
► Status of shell cover after opening

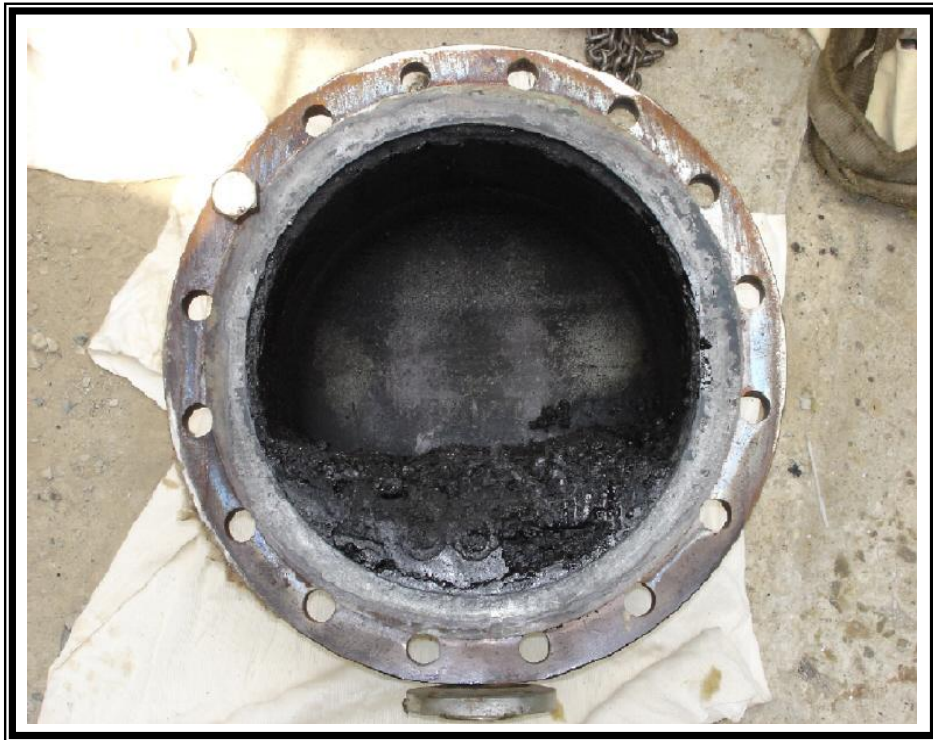
► Status of other side shell cover after opening

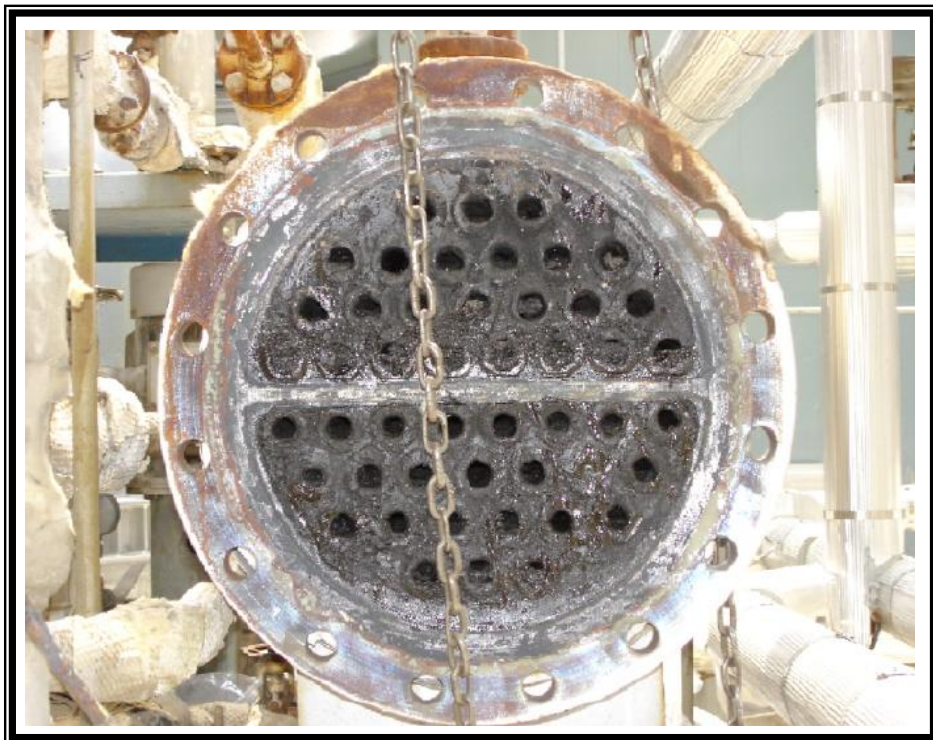
► Status of exchanger shell tube after opening

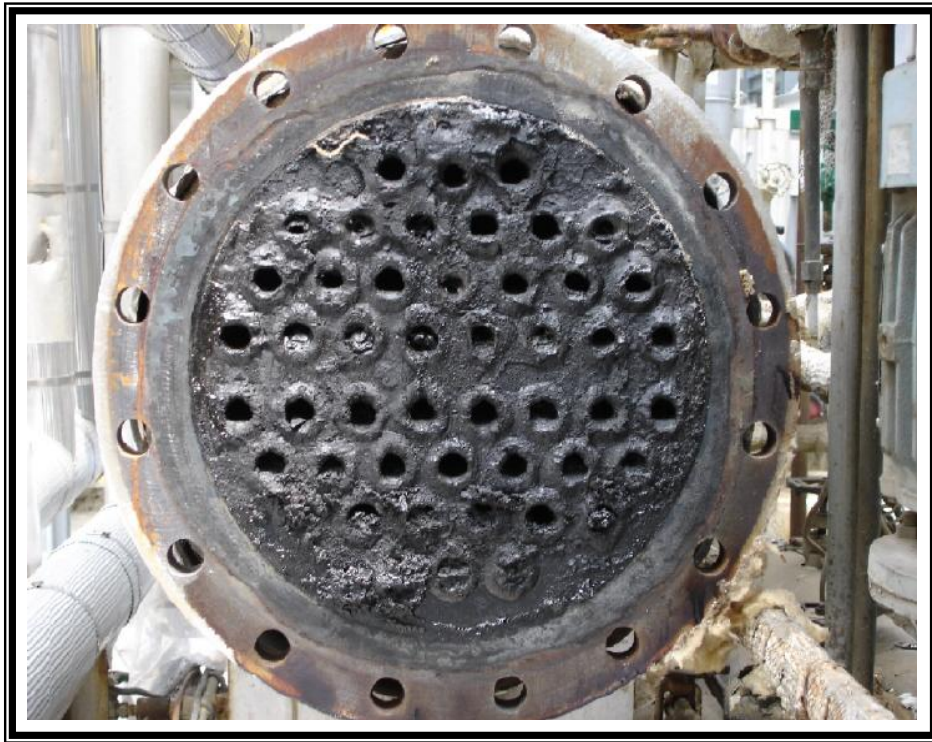
▶ Status of other side of shell tube

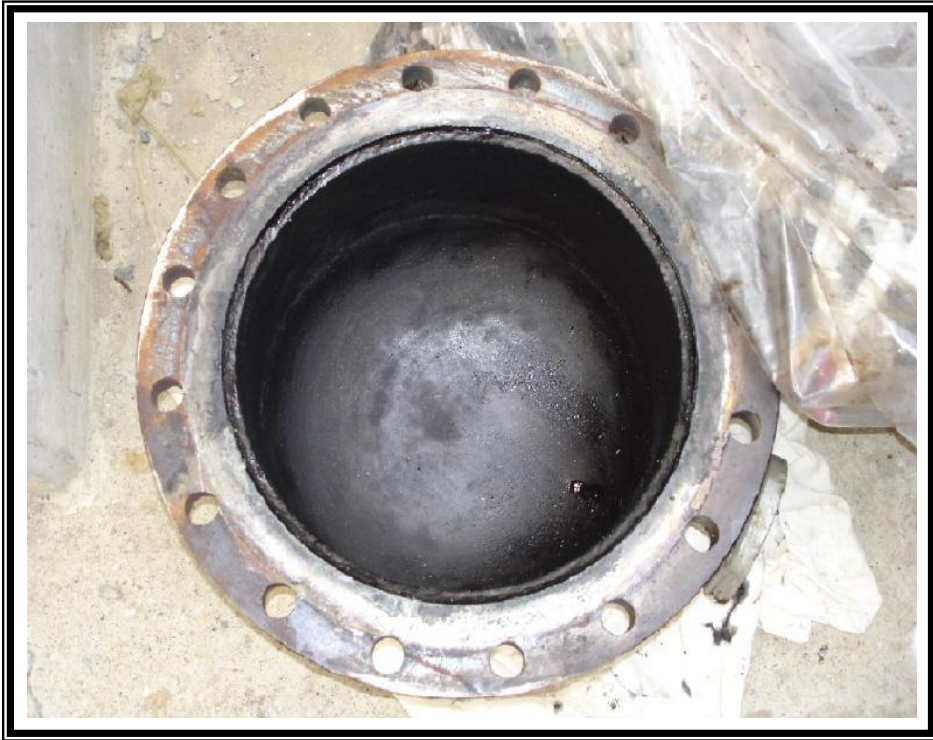
► Cover status after cleaning

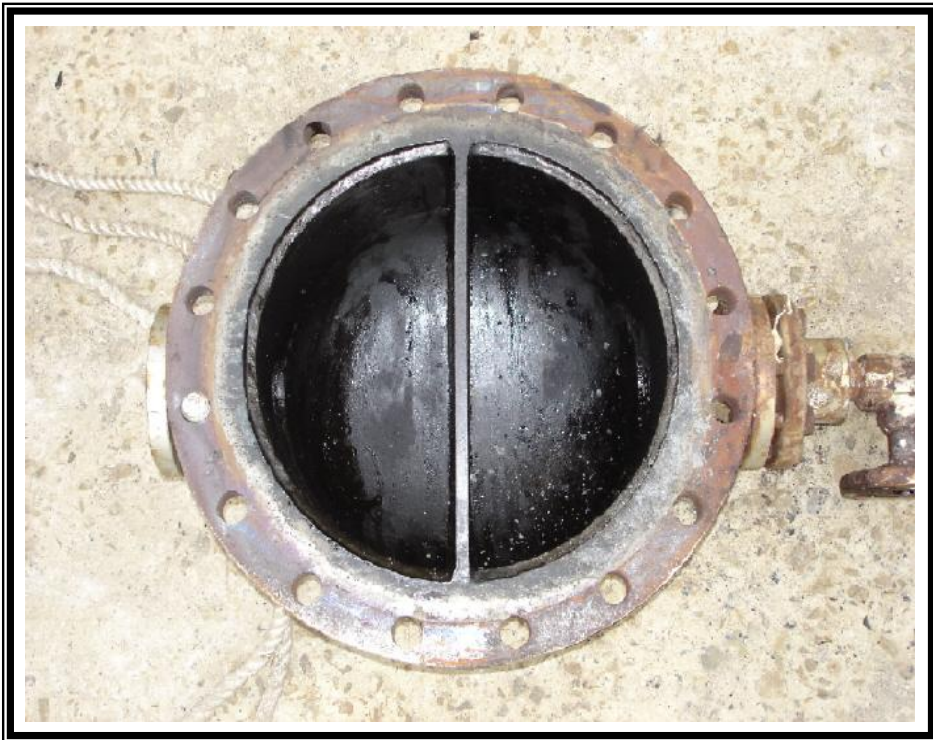
► Other side cover status after cleaning

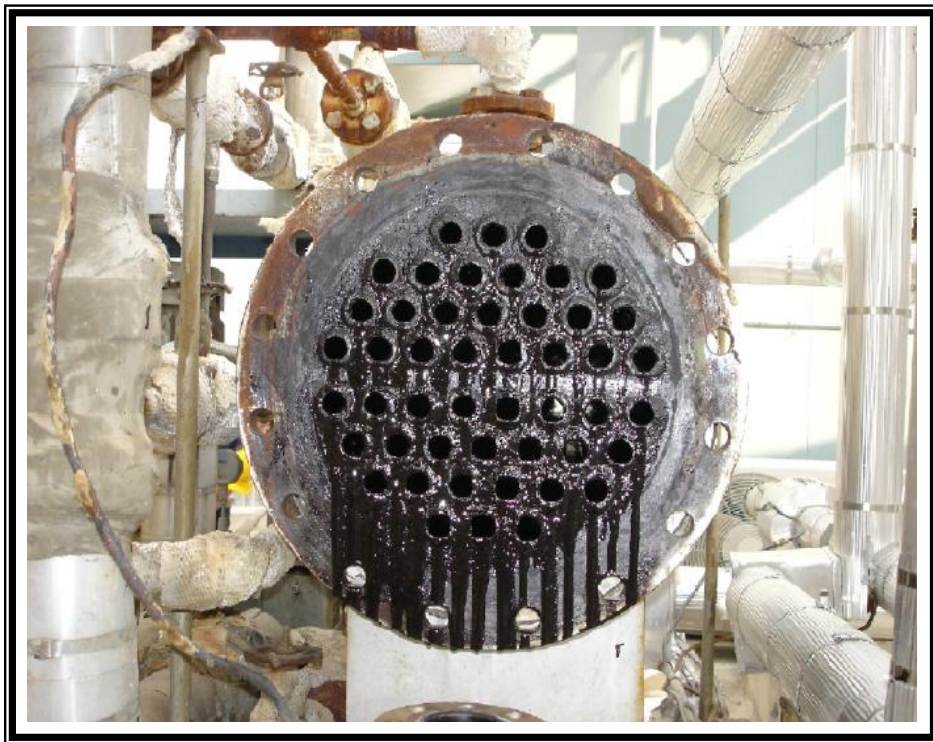
► Status of tube after cleaning

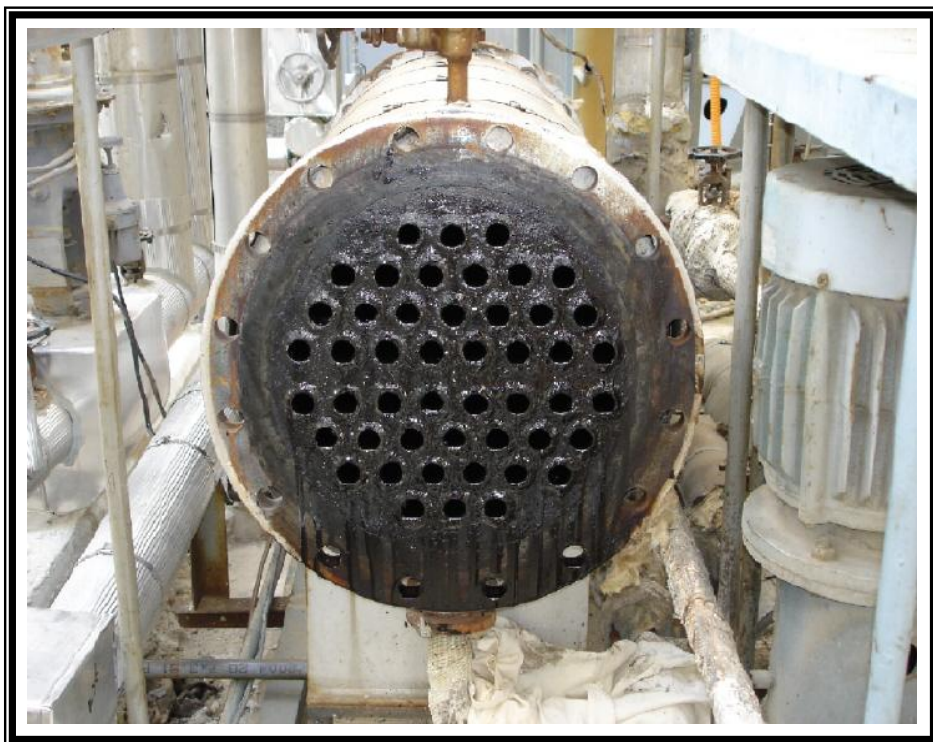
► Status of other side tube after cleaning
